## "Full" Reserve Study

### Vista Valley Subdivision HOA Fruita, CO

**Report #: 37401-0**

**Date Prepared: August 14, 2019**

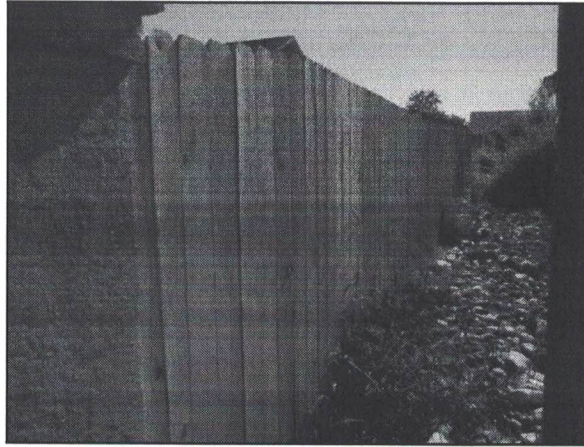
**Comp #: 21320 Site Fencing: Wood - Repair/Paint**

Comments: Wood fencing determined to be in fair to poor condition typically exhibits a finish coat which is mostly uniform but exhibits moderate surface wear or fading possibly exposing wood substrate in some areas. Regular uniform professional paint or sealer applications are recommended for appearance protection of wood and maximum design life. Repair as needed and clean prior to application. Plan for regular applications as shown below. Timing of repair/paint cycles may need to be coordinated with eventual fence replacement.

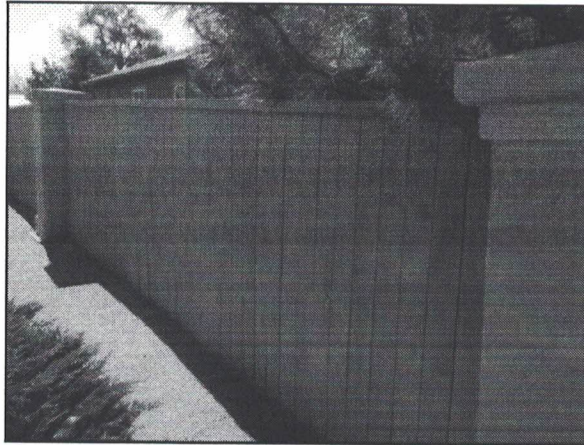
**Comp #: 21330 Site Fencing: Wood - Replace**

Comments: Wood fencing determined to be in fair condition typically exhibits some minor to moderate amounts of surface wear and other signs of age which may include a small percentage of warped split and/or rotted sections. In general appearance is consistent but declining. As routine maintenance inspect regularly for any damage repair as needed and avoid contact with ground and surrounding vegetation wherever possible. Regular cycles of uniform professional sealing/painting will help to maintain appearance and maximize life. In our experience wood fencing will typically eventually break down due to a combination of sun and weather exposure which is sometimes exacerbated by other factors such as irrigation overspray abuse and lack of preventive maintenance. Recommendation and costs shown here are based on replacement with similar style and material. However the client might want to consider replacing with more sturdy lower-maintenance products like composite vinyl etc. Although installation costs are higher total life cycle cost is lower due to less maintenance and longer design life expectancy.

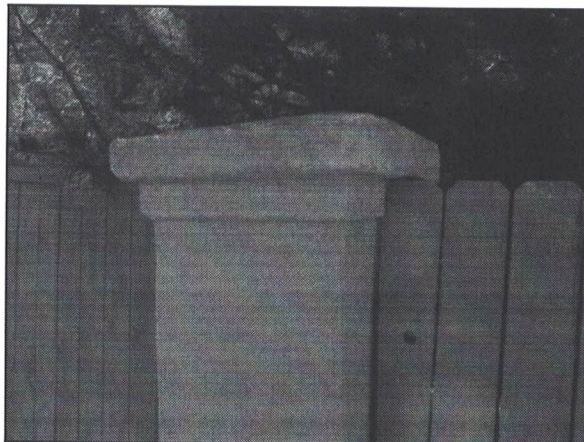
**Comp #: 21390 Stucco Columns – Repair/Paint**

Comments: At this time costs related to this component are expected to be included in the client's Operating budget. No recommendation for Reserve funding at this time. However any repair and maintenance or other related expenditures should be tracked and this component should be re-evaluated during future Reserve Study updates based on most recent information and data available at that time. If deemed appropriate for Reserve funding component can be included in the funding plan at that time.

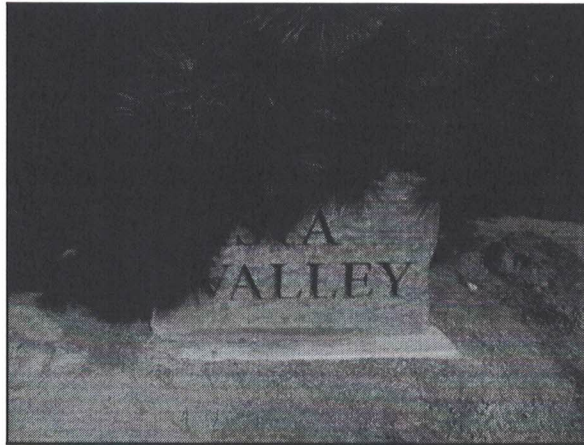
**Comp #: 21610 Sign/Monument - Refurbish/Replace**

Comments: Monument signage determined to be in good condition typically exhibits good appearance and aesthetics in keeping with local area. Generally uniform and attractive finishes. If present lettering is clean complete and legible and any surrounding landscaping lighting etc. is attractive and functioning. As routine maintenance inspect regularly clean/touch-up and repair as an Operating expense. Plan to refurbish or replace at the interval below. Timing and scope of refurbishing or replacement projects is subjective but should always be scheduled in order to maintain good curb appeal. In our experience most clients choose to refurbish or replace signage periodically in order to maintain good appearance and aesthetics in keeping with local area often before signage is in poor physical condition. If present concrete walls are expected to be painted and repaired as part of refurbishing but not fully replaced unless otherwise noted. Costs can vary significantly depending on style/type desired and may include additional costs for design work landscaping lighting water features etc. Reserve Study updates should incorporate any estimates or information collected regarding potential projects.

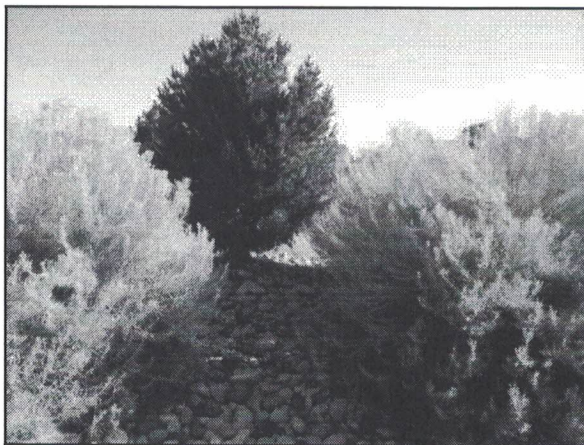
Comments: In general costs related to this component are reported to be included in the client's Operating budget. No recommendation for Reserve funding at this time. However any repair and maintenance or other related expenditures should be tracked and this component should be re-evaluated during future Reserve Study updates based on most recent information and data available at that time. If deemed appropriate for Reserve funding component can be included in the funding plan at that time.

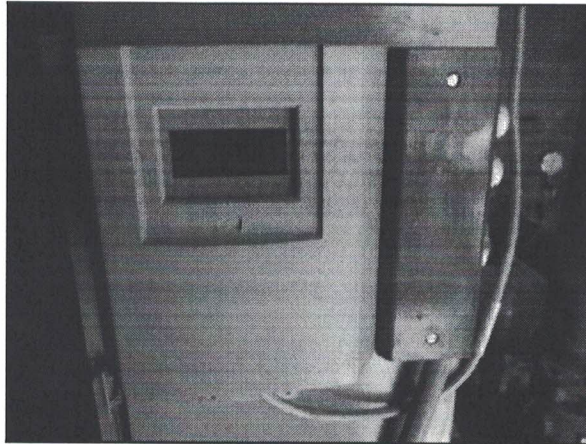
**Comp #: 25270 Badger Flow Meter – Replace**

Comments: Minimal or no subjective/aesthetic value for this component. Useful life is based primarily on normal expectations for service/performance life in this location. Unless otherwise noted remaining useful life expectancy is based primarily on original installation or last replacement/purchase date our experience with similar systems/components and assuming normal amount of usage and good preventive maintenance. Pump(s) can often be repaired or rebuilt rather than completely replaced. Motor rebuilds and other repairs are often considered an Operating expense. Pumps and motors need to be checked and serviced regularly by vendor or other maintenance personnel to ensure proper function. If possible equipment should be protected from sunlight and weather to minimize exposure and prolong life. Costs to replace are based on similar size and horsepower. If there is more than one pump in place cost ranges shown below are based on complete replacement of all pumps at one time usually based on similar/same age and expectation of comparable life expectancy.

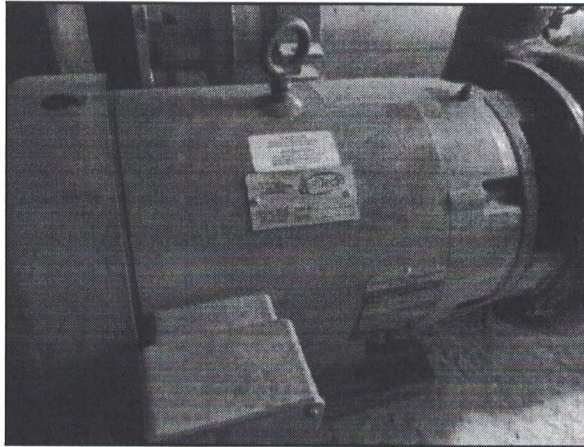
**Comp #: 25280 Baldor Motor - Repair/Replace**

History: Reportedly replaced in 2017

Comments: Baldor pump with a Berkely pump. Unit is a 3 phase 15 HP. Minimal or no subjective/aesthetic value for this component. Useful life is based primarily on normal expectations for service/performance life in this location. Unless otherwise noted remaining useful life expectancy is based primarily on original installation or last replacement/purchase date our experience with similar systems/components and assuming normal amount of usage and good preventive maintenance.

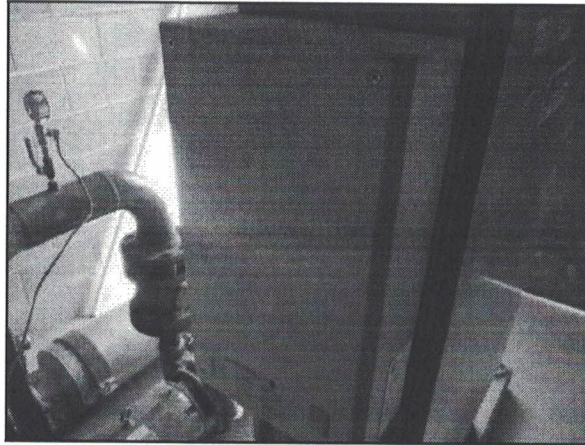
**Comp #: 25290 Fan Unit – Replace**

Comments: Rittal unit. SK 3217115. Minimal or no subjective/aesthetic value for this component. Useful life is based primarily on normal expectations for service/performance life in this location. Unless otherwise noted, remaining useful life expectancy is based primarily on original installation or last replacement/purchase date, our experience with similar systems/components, and assuming normal amount of usage and good preventive maintenance. We recommend that routine repairs and maintenance such as filter replacements, system flushing, etc. be budgeted as an Operating expense. Useful life can often be extended with proactive service and maintenance. Unless otherwise noted, funding for system with same size/capacity as the current system. For split systems, we recommend budgeting to replace the entire system (condensing unit and air handler) together in order to obtain better unit pricing and ensure maximum efficiency, refrigerant compatibility, etc. If additional costs are expected during replacement, such as for system reconfiguration or expansion, ductwork repairs, electrical work, etc. costs should be re-evaluated and adjusted as needed during future Reserve Study updates.

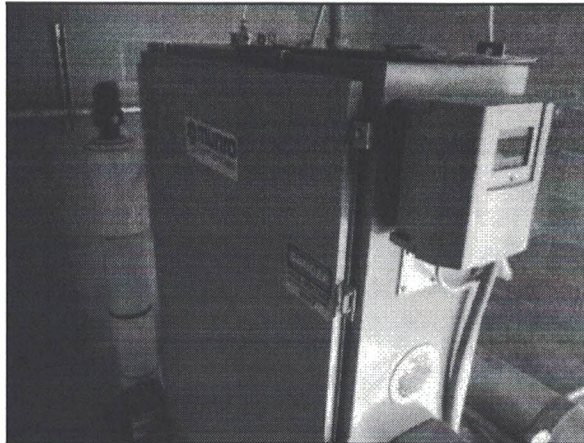
**Comp #: 25300 Variable Frequency Drive - Replace**

Comments: Yaskawa F7 drive. Minimal or no subjective/aesthetic value for this component. Useful life is based primarily on normal expectations for service/performance life in this location. Unless otherwise noted remaining useful life expectancy is based primarily on original installation or last replacement/purchase date our experience with similar systems/components and assuming normal amount of usage and good preventive maintenance. Variable frequency drives (AKA variable speed drives) are used to control output of mechanical equipment when full power is not required at all times. Should be inspected and repaired as needed by servicing vendor to ensure proper function and optimal performance. Unless otherwise noted assumed to be functional and in good condition. Plan to replace at the approximate interval shown below. The payback period for these systems measured in energy savings is often a fraction of the design life of the unit itself.

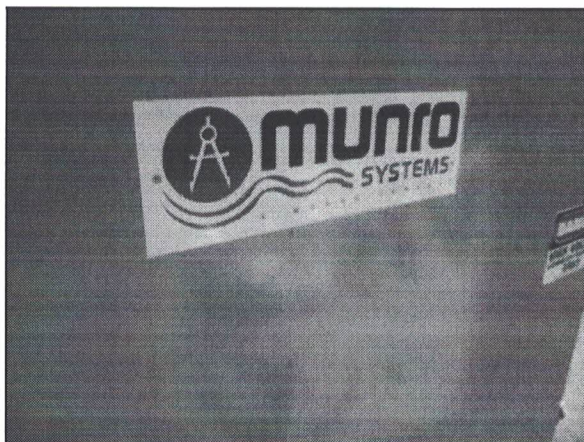
**Comp #: 25340 Munro Equipment – Update/Replace**

Comments: Vendor reported that the unit is operational with no reported issues at this time. No recommendation for Reserve funding at this time. However any repair and maintenance or other related expenditures should be tracked and this component should be re-evaluated during future Reserve Study updates based on most recent information and data available at that time. If deemed appropriate for Reserve funding component can be included in the funding plan at that time.

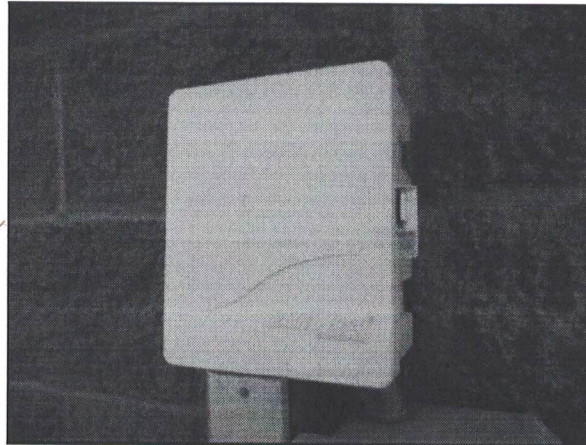
**Comp #: 25570 Irrigation Clock - Replace**

Comments: Includes (1) Rain Bird unit. Replaced in 2004. Serial - 0413453. Appears to be a (2) station clock. In general costs related to this component are expected to be included in the client's Operating budget. No recommendation for Reserve funding at this time. However any repair and maintenance or other related expenditures should be tracked and this component should be re-evaluated during future Reserve Study updates based on most recent information and data available at that time. If deemed appropriate for Reserve funding component can be included in the funding plan at that time.

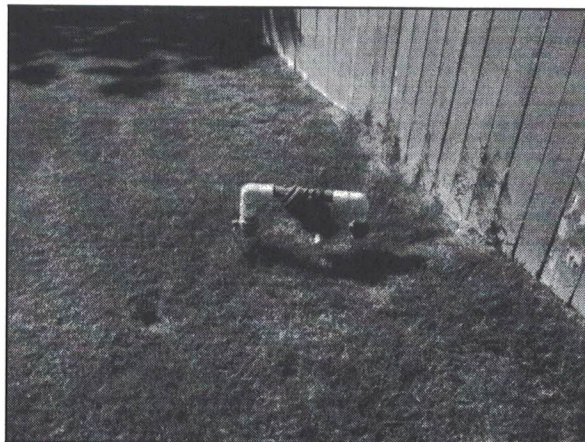
**Comp #: 25580 Irrigation System - Repair**

Comments: At the request of the client we have included an allowance for ongoing annual line breaks based upon the historical averages of the association. As routine maintenance inspect regularly test system and repair as needed from Operating budget. We recommend consulting with irrigation vendor to determine what types of repairs and replacements are included in the landscaping contract. If properly installed without defect most of the elements within this system (distribution piping valves sprinkler heads etc) are generally low-cost and have a failure rate that is difficult to predict making routine repairs best-suited to be handled through the Operating budget. However in some instances Reserve funding can be warranted based on actual project history or expectations for major repairs/replacements. The life expectancies and cost estimates shown here should be re-evaluated during future Reserve Study updates.
